ZONE 11 Hewitts Creek from 'straightened' section eastward to bridge		
Soil	Original soil profile intact with minimal disturbance	
Vegetation Communities	<ul style="list-style-type: none"> • <i>Banksia integrifolia</i> \ <i>Casuarina glauca</i> dominated estuarine community • Significant occurrences of characteristic plant species for the SCESFC 	
Weed Density	Low	
Habitat Value	HIGH	<ul style="list-style-type: none"> • The creek line bank is a significant nesting area for Spotted Pardalote with nesting sites evident. • <i>Phragmites australis</i> is growing approximately 5 metres into water offering significant habitat. • The abundance of roosting birds was noted in mature Casuarinas on creek bank • Sighting of fish in water, although species unidentified.
Major Impacts	<ul style="list-style-type: none"> • Despite the major impacts to Hewitts Creek immediately upstream of this section, the riparian areas of this zone remain predominantly stable and healthy. • Informal track networking along the foreshore of the creek is an issue. • Some weed invasion is present.

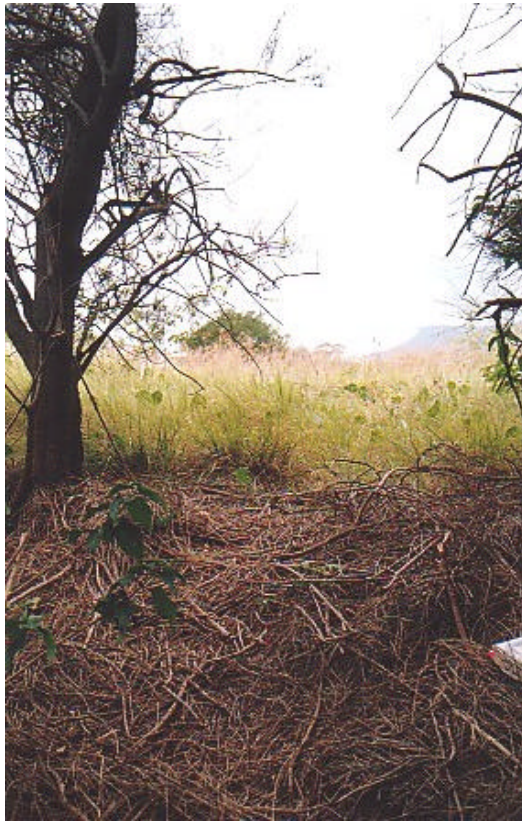
Plate 43: Zone 11 looking south from Hewitts Creek bank beneath Banksia and Casuarina canopy. Note healthy native grassland community.

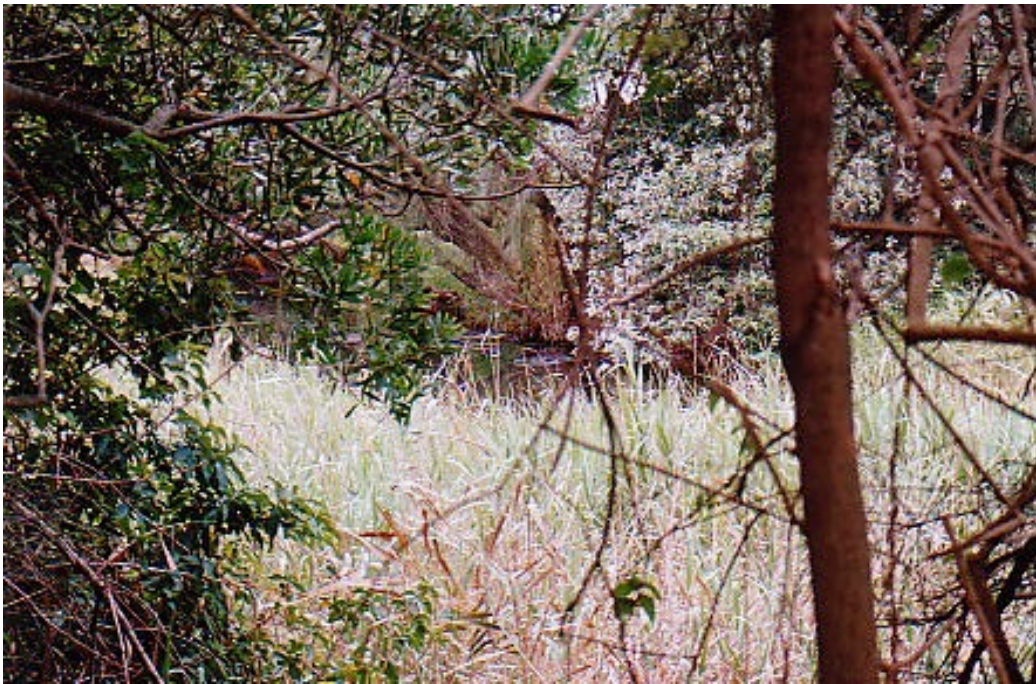
Plate 44: Looking north across Hewitts Creek in Zone 11, downstream from major impacts. Note healthy, multi-level riparian vegetation, presence of mature tree providing significant habitat.

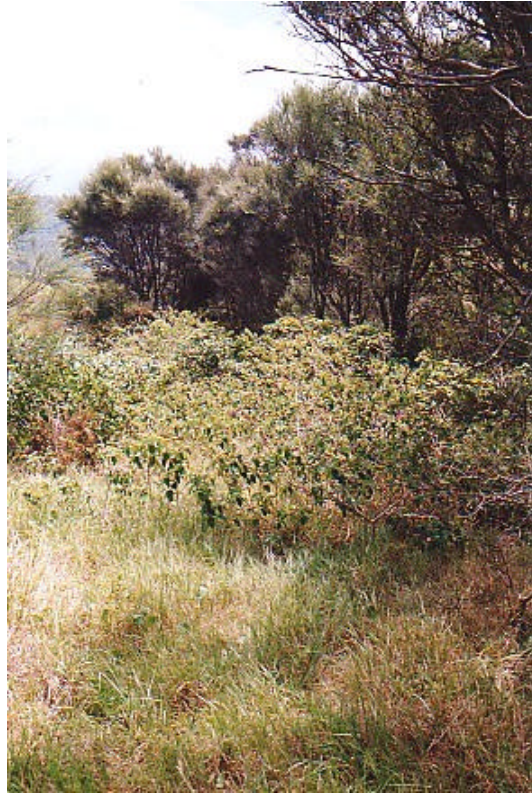
Plate 45: Looking west long Hewitts Creepline in Zone 11 showing native grass community in foreground. Note some woody weed invasion at edge of Casuarinas.

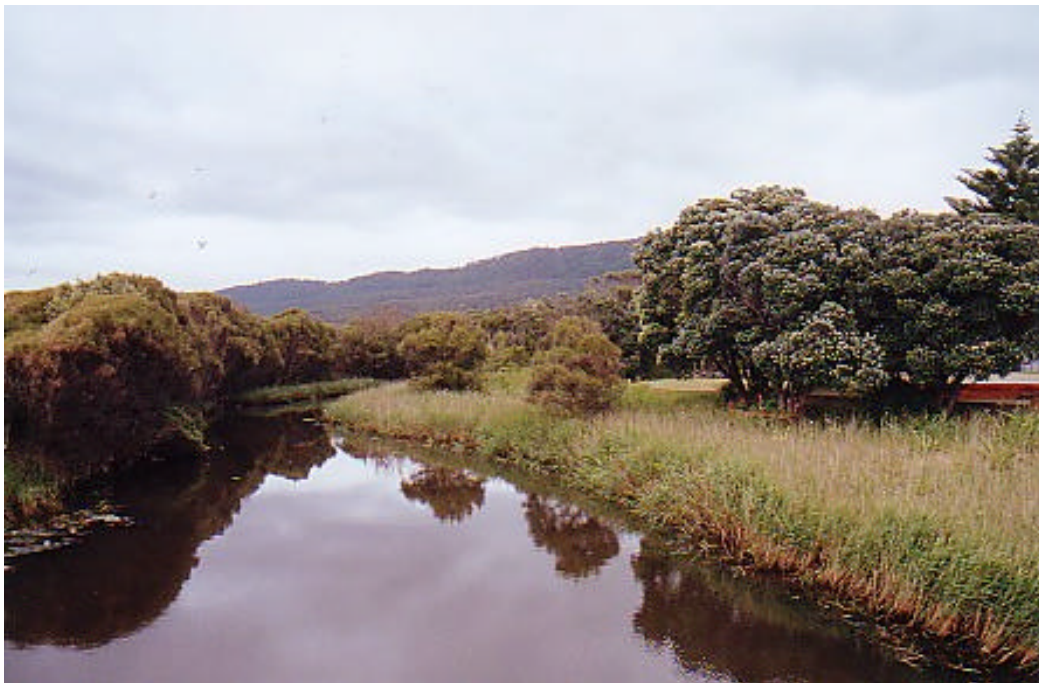
Plate 46: Zone 11 looking west up Hewitts Creek to Illawarra Escarpment from footbridge/cycle way. Note proximity of urban interface on northern side of the creek.
