Zone 2 – Tramway Creek (west of paved bicycle path culvert)		
Soil	Original soil profile intact and with minimal site disturbance along creek as evidenced by the thick stand of native grass <i>Themeda australis</i> and isolated shrubs of <i>Melaleuca styphelioides</i> . Disturbance and fill is evident in the western sector of the zone closer to the old tram line and present railway line.	
Vegetation Communities	<ul style="list-style-type: none"> • Presence of all three vegetation units that collectively form the Sydney Coastal Estuarine Swamp Forest Community (SCESFC) Endangered Ecological Community [see Appendix E] • Remnant native grassland community (approximately 1500sqm) on the southern bank of Tramway Creek contiguous to the scrubland vegetation unit of the SCESFC consisting of <i>Melaleuca styphelioides</i> • Woody and herbaceous weeds 	
Weed Density	Low to High	Low in the remnant native grassland community Medium in the SCESFC High in the woody weed infestation in the western sector <i>Predominantly herbaceous annual weeds with some woody weed infestation</i>

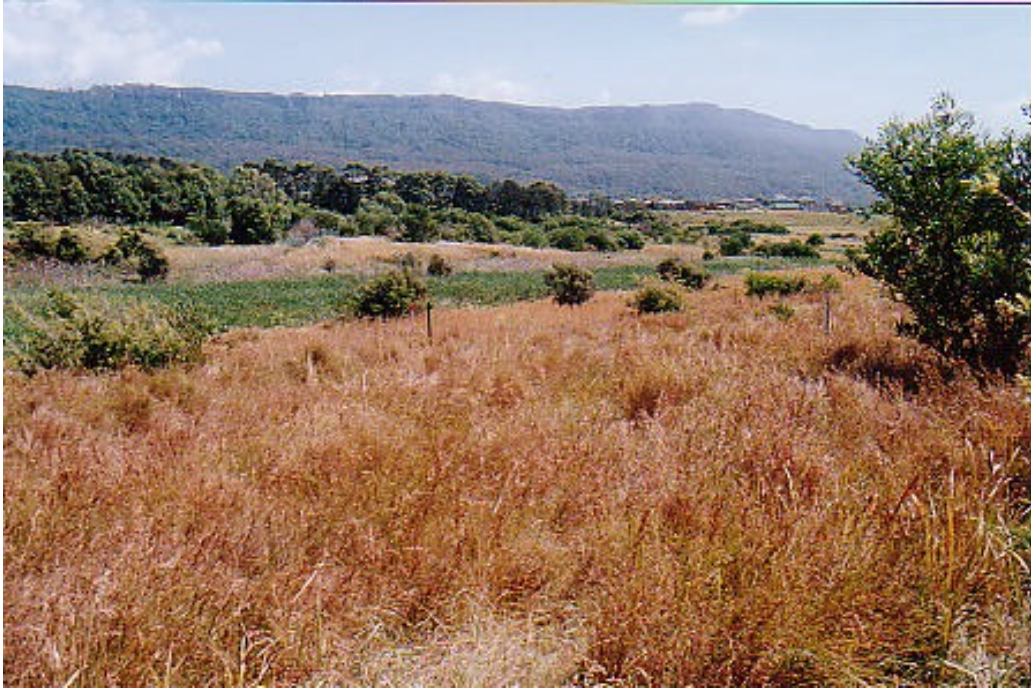
Plate 8: From Zone 2 looking north-west to Zone 4. Remnant native grassland community in foreground, Sydney Coastal Estuarine Swamp Forest Complex and Tramway Creek in mid-ground.

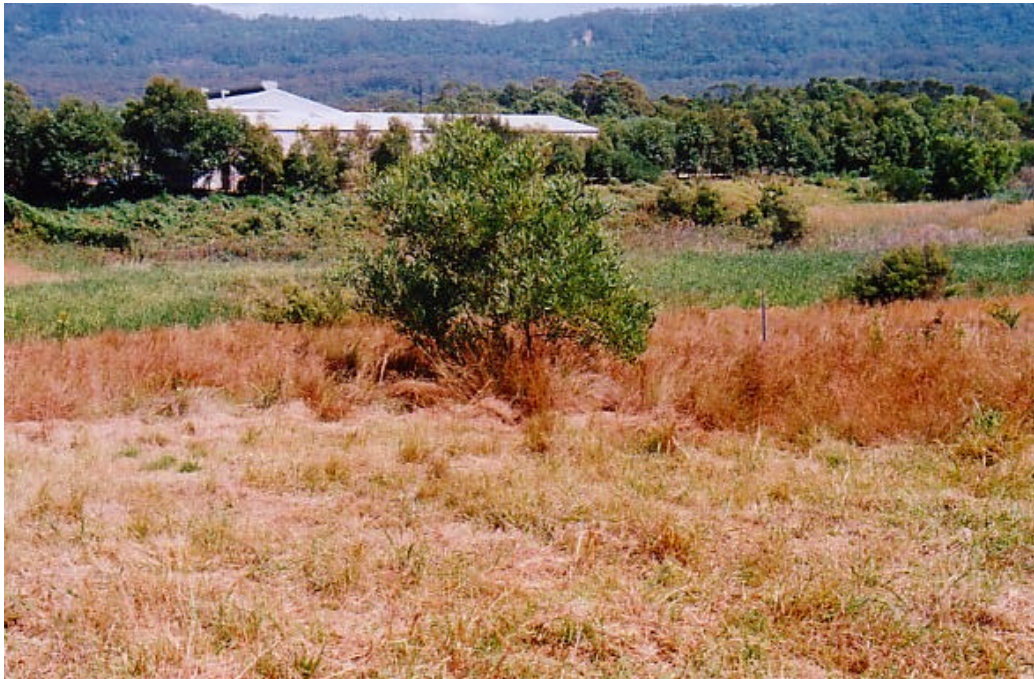
Plate 9: Zone 2 Slashing impacts on native grassland community with SCESFC and Tramway Creek behind.

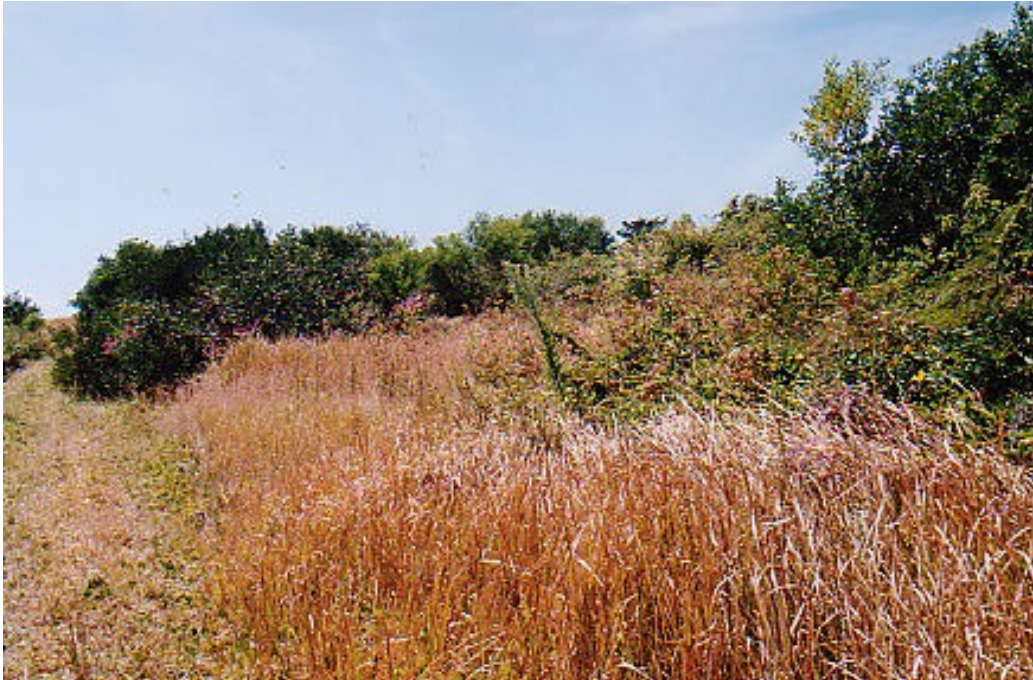
Plate 10: Zone 2 Looking east. Bird habitat area in western sector of the zone.

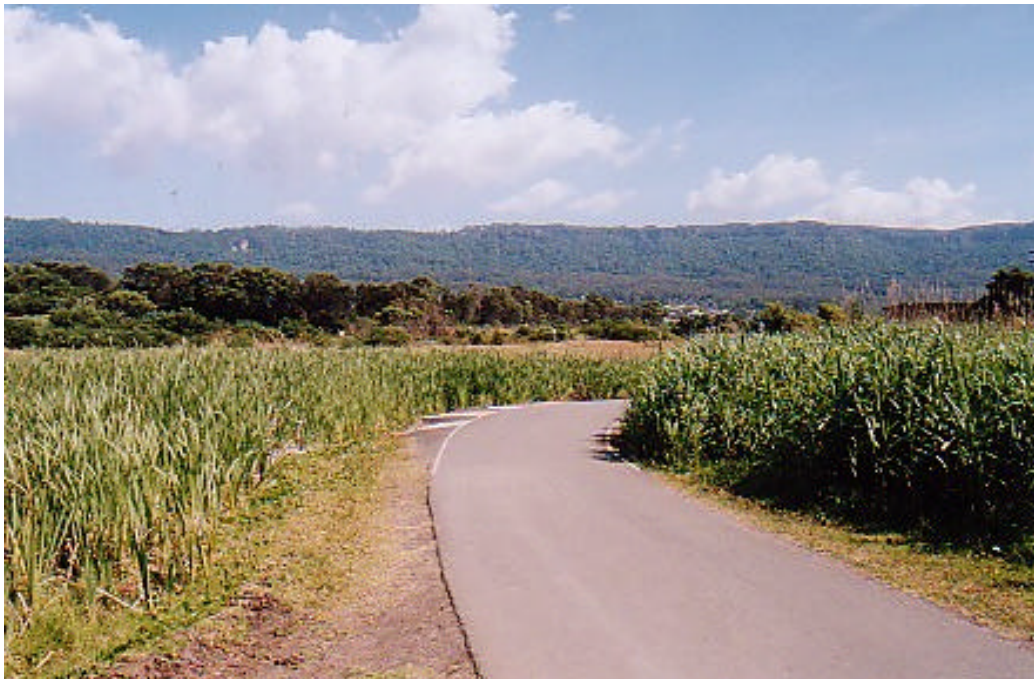
Plate 11: Zone 2 Looking north-west at culvert over Tramway Creek. Note dominance of *Typha orientalis* on left and *Phragmites australis* on right indicating some interference of water flow and/or tidal interchange. Also note uninterrupted green corridor view across Zone 3 and 4 to the Illawarra Escarpment.
