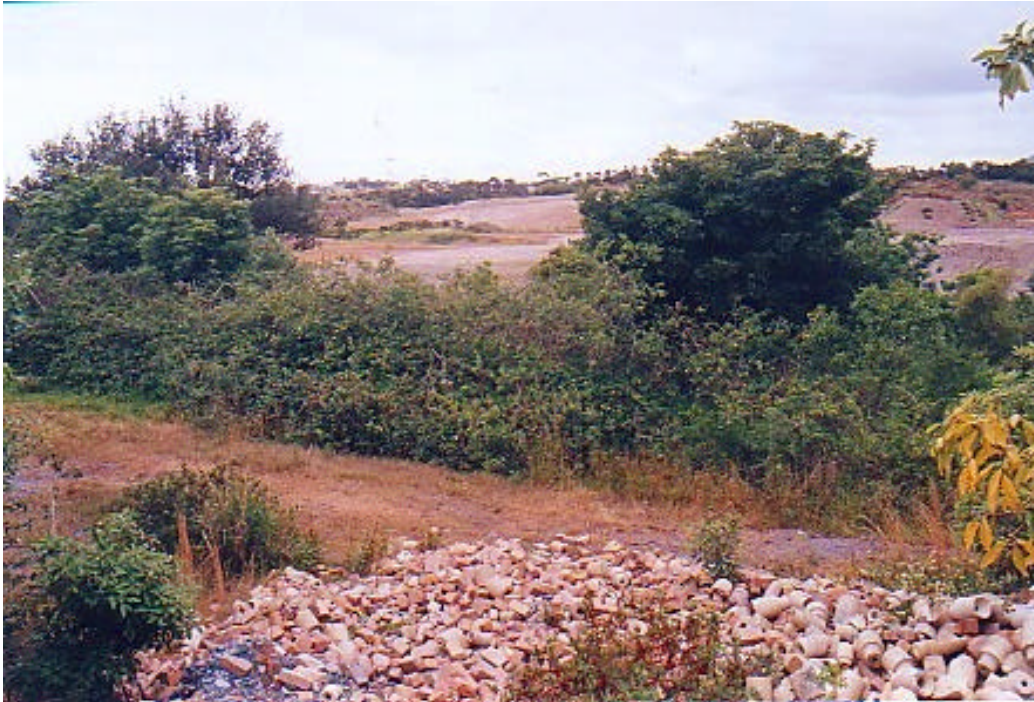
**Plate 27:** Looking south from Zone 8 across 'straightened' section of Hewitts Creek to Zone 7 (piped section of Woodlands Creek)

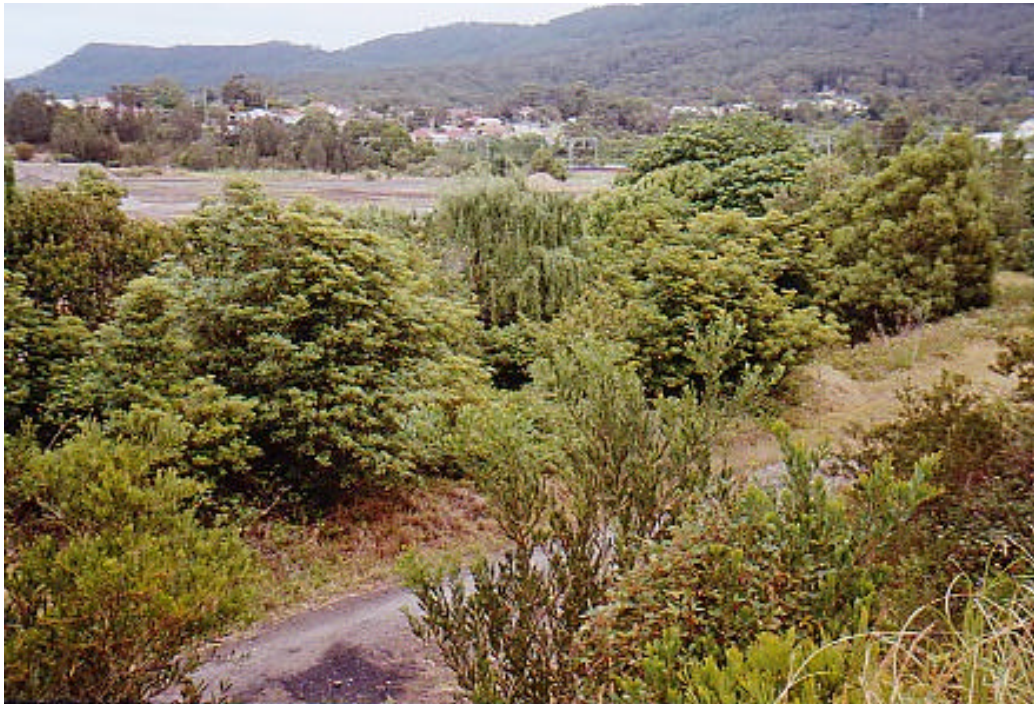
**Plate 28:** Looking south-west from Zone 8 across 'straightened' section Hewitts Creek toward Illawarra Escarpment. Creepline dominated by introduced species.

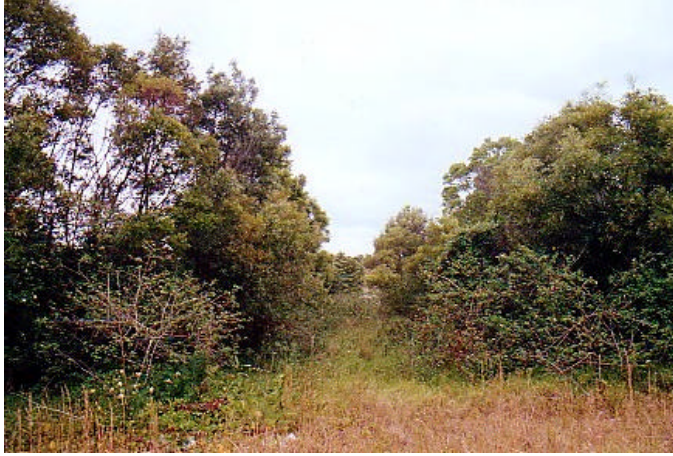
**Plate 29:** Acacia dominated vegetation of Zone 8 with weedy understorey dominated by Lantana.

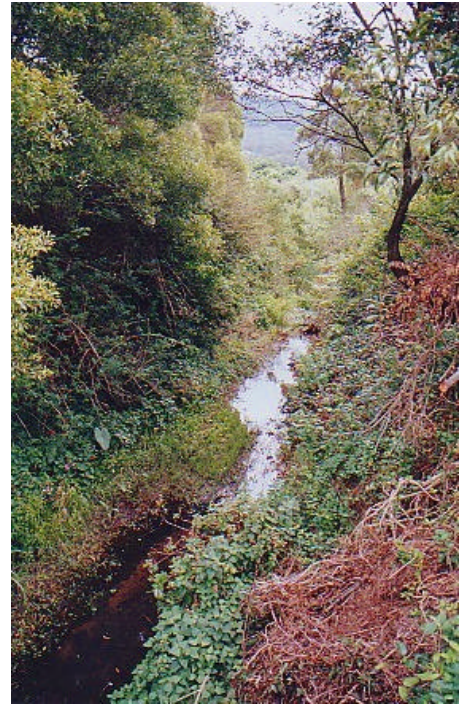
**Plate 30:** Looking west along Hewitts Creek through Zone 8 showing weed invasion and scouring.

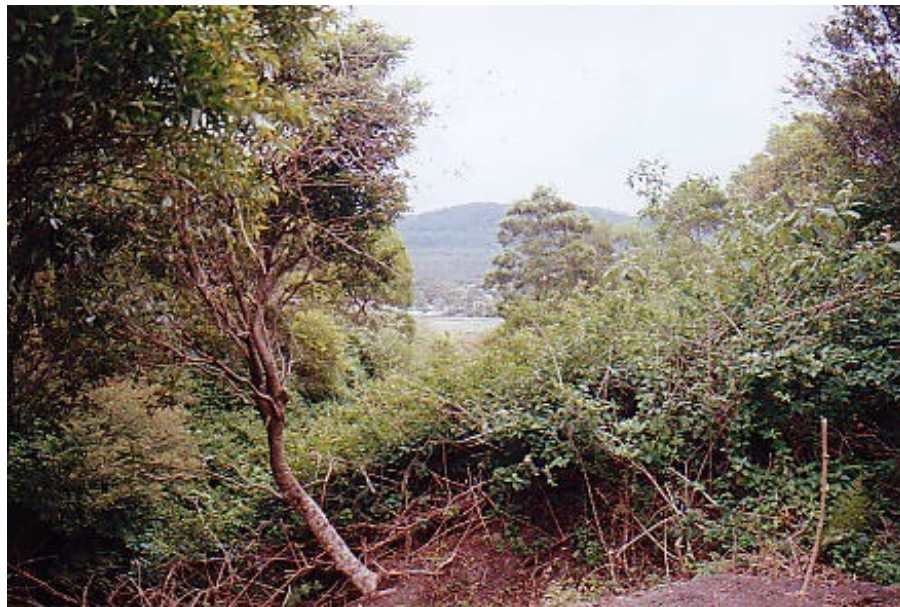
**Plate 31:** Looking west into Zone 8 along northern edge of 'straightened' section of Hewitts Creek showing dominant weed understorey.

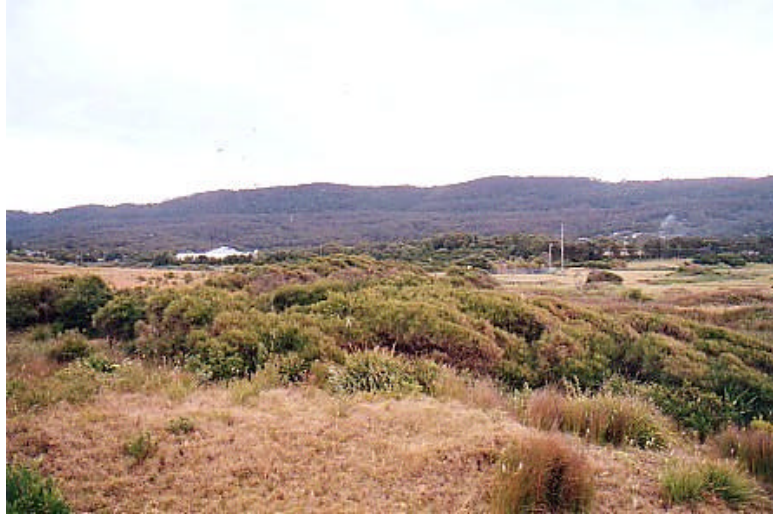
**Plates 48:** (above) Looking west from Zone 12 Coastcare site through to Illawarra Escarpment. **Plate 49:** (below) Looking south through Zone 12 Coastcare site.
