Zone 10 <u>Hewitts Creek from confluence of piped Woodlands Creek to section of 'straightened' creek line (including gabion section) south of Corbett Avenue</u>		
Soil	Some original soil profile with signs of increased sedimentation and nitrification within riparian zones Extensive disturbance from re-routing of stream and gabion works near confluence of piped Woodlands Creek Disturbance along altered creek line, although strong evidence of resilience	
Vegetation Communities	<ul style="list-style-type: none"> • Remnant <i>Banksia integrifolia</i> \ <i>Allocasurina distyla</i> estuarine community • Remnant littoral rainforest community flagged with the noting of species such as <i>Ficus coronata</i> (Sandpaper Fig) and <i>Livistona australis</i> (Cabbage Tree Palm). • Woody and herbaceous weeds • Significant occurrences of characteristic species of the SCESFC 	
Weed Density	Medium - High	
Habitat Value	HIGH	<ul style="list-style-type: none"> • Thick pockets of weed infestation provide significant habitat for small birds and mammals. • High resilience is indicated by the appearance of native species in sections of the creek-line that are closely following the original water course of

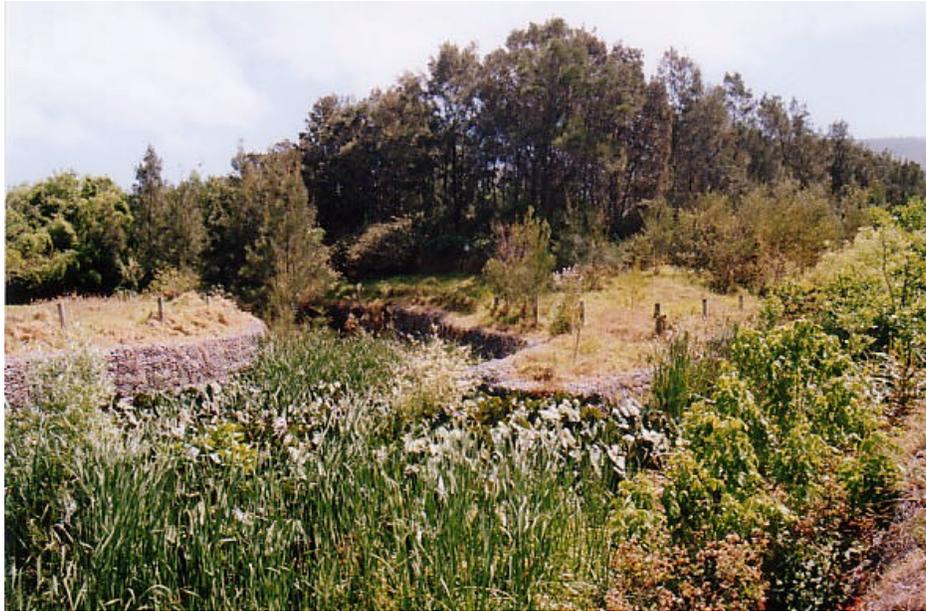
Plate 34 & 35: Looking west from the gabion diversion of Woodlands Creek into the protective fencing and Casuarina's of remnant Hewitts Creek swamp wetland in Zone 9. Note the high density weed at the foreground in the gabion constructed channel.

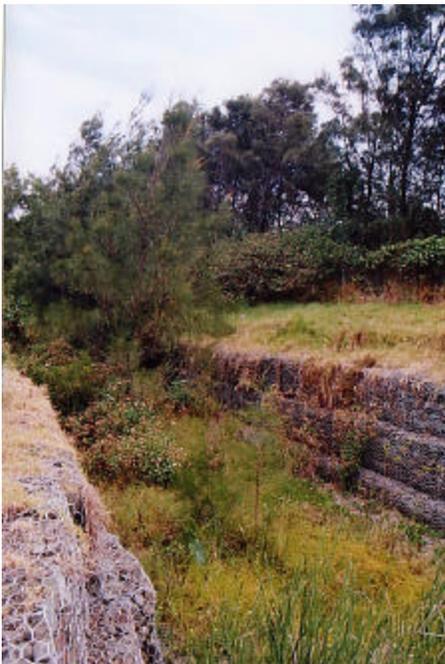
Plate 36: Looking south-west from northern bank of gabioned section Hewitts Creek in Zone 10. Casuarina grove in centre background defines the edge of the remnant swamp wetland of Zone 9. Note weed domination in constructed channel.

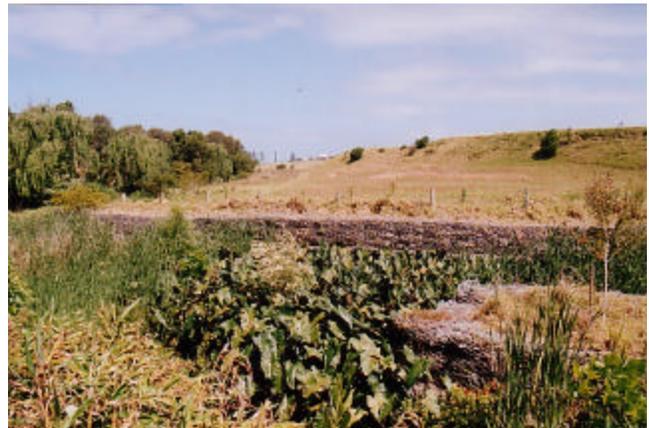
Plate 37: Looking south through constructed gabion diversion channel between Woodlands and Hewitts Creeks. Casuarinas in Zone 9 at background.

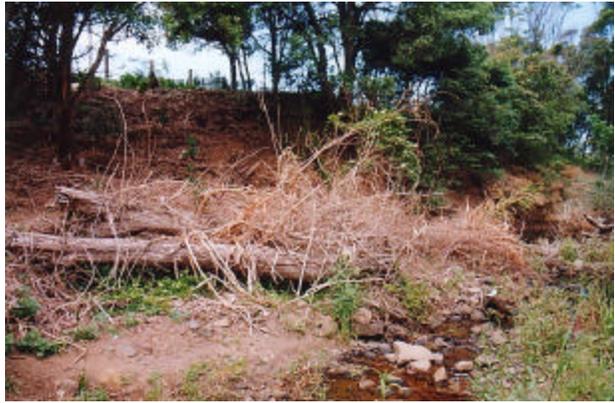
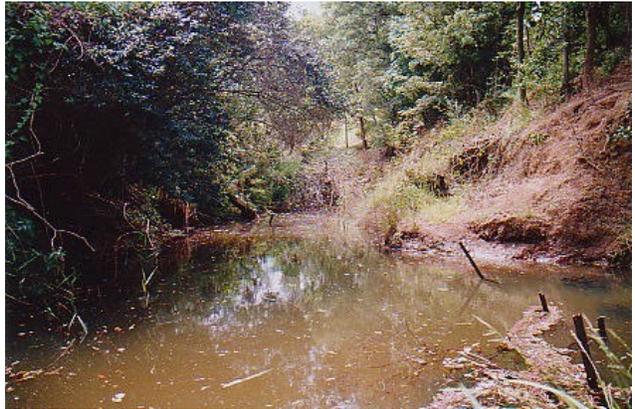
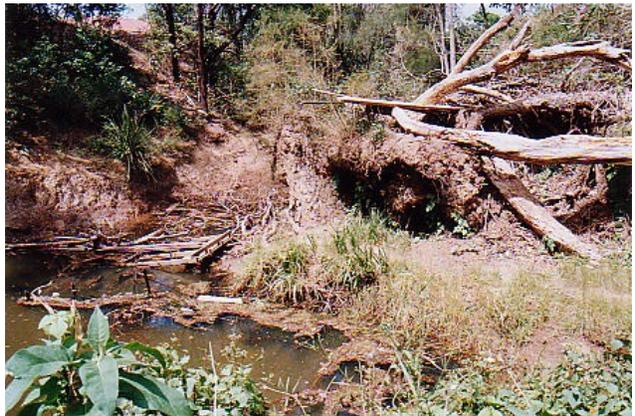
Plates 39 – 42: Views of scoured and eroded section of Hewitts Creek through Zone 8 where creekline 'straightened' downstream of gabion channelling.
